Chicago, Illinois
May 2-7, 2010

Paper F-1-03

Multi Trenchless Discipline Project for on Grade Sanitary Installation with Unique Design Challenges

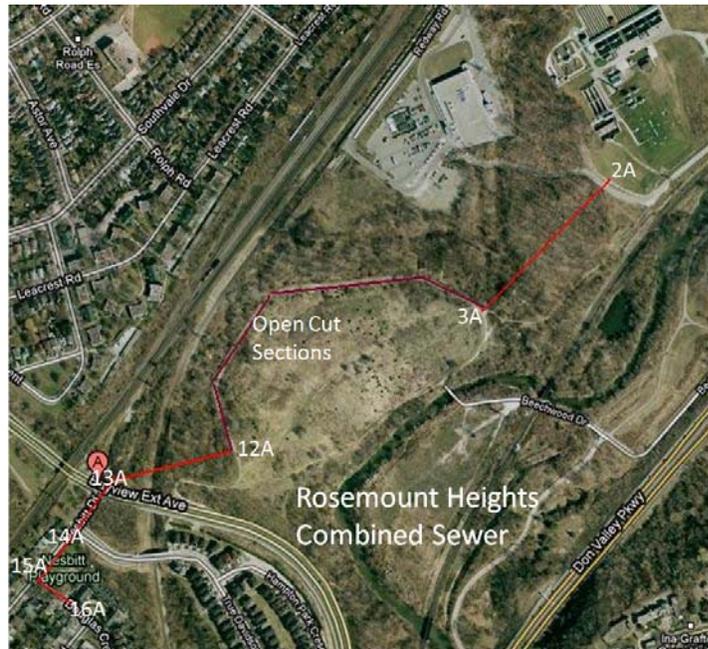
Figure 1. Graphic of overall project area – Rosemount Heights, Toronto, ON - source Google Maps

The trenchless portions of the project are laid out in Table 1, with a visual representation in Figure 1.

Section	Length / Grade	Method	Details
2A to 3A	217m / 3.6%	HDD	508mm IPS DR 6.3 HDPE
12 to 13A	175m / 6.2%	HDD	508mm IPS DR 6.3 HDPE
14A to 13A	111m / 0.7%	Auger Bore	1200mm Steel Liner with 400mm PVC DR 18
14A to 15A	69.5m / 0.7%	Auger Bore	1200mm Steel Liner with 400mm PVC DR 18
16A to 15A	54m / 0.7%	Auger Bore	1200mm Steel Liner with 400mm PVC DR 18

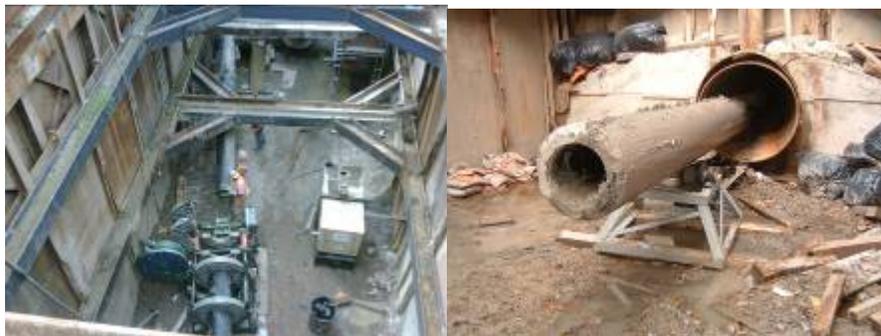
Figure 2. Fusion of HDPE pipe and threading through 1200mm liner

Earth Boring suggested that order of construction would develop the best solution. In this method, the 1200mm liner for sections 14A to 15A and 14A to 13A would be installed first by the design method of auger bore. At the conclusion of this work, the HDPE pipe would be fused in the shaft at 14A. It would then be threaded to the East to shaft 13A and again West to shaft 15A. A single fuse would be required to complete the 174m length of HDPE pipe. This solution was indeed applied and was highly efficient and successful. See Figure2.

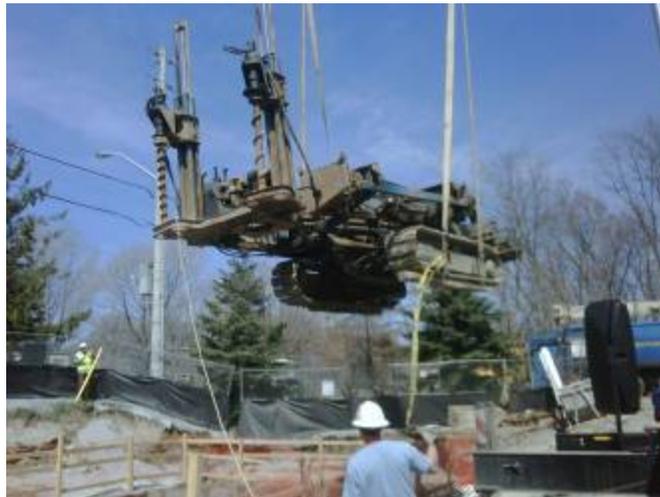
Figure 3. Lowering HDD rig into shaft 14A for pilot auger bore operation

With great success, the HDD pilot tube was installed for 14A to 13A. A Robbins 4510 was lowered (Figure 3) into 14A and staged to the proper line and grade of the overall design.

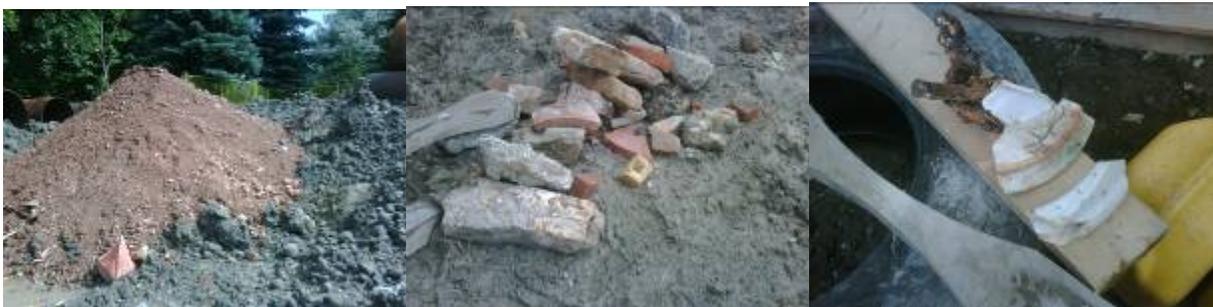
Figure 4. Debris spoil from tunnel installation - MH14A to MH13A – Vastly different from expectation

At 48.7m, the pressures returned and with that pressure, a very different soils matrix. What had been a grey clay, had become a reddish brown sloppy mess. As the bore progressed dry material of the same color was extracted (Figure 4 – left).

Investigation of the spoil pile concluded that indeed brick material had been encountered. Some fully intact bricks had been extracted including a stamped name of the manufacturer (Figure 4 – middle).

For the next 13m the spoil varied in composition. Pieces of cement, brick, foundation stone, wood debris and glass bottles were found in the spoil. As the bore progressed to the 61m mark, clay tile pipes, ceramic, railway spikes, and more concrete and wood debris were encountered. The most interesting piece of debris was the rim of a toilet (Figure 4 - right).

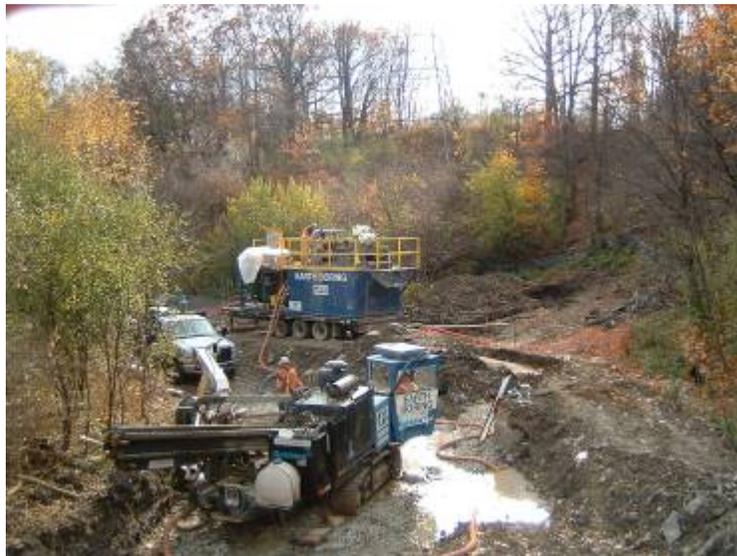
Figure 5 – MH12A to MH13A HDD rig set up – area cut down 1.5m

This installation proceeded fairly well. Early field work prior to crew mobilization assisted in the smooth operation. These efforts included active and passive frequency interference detection, staging of equipment layout, survey line installation and area pre-cut. Area pre-cut is a beneficial method of reducing required set-back room for drilling. By cutting down the area where a drill is to be staged, the driller can then effectively attain key grade points in a shorter distance, depending on the expected profile of the bore. In this project the drill staging area was cut down 1.5m reducing the set back distance by over 15m. (Figure 5) This process is especially effective in areas where the ROW is very limited.
